TEST REPORT: 7191245311-CHM20-MA

Evaluation of "MICALITE DECORATIVE LAMINATE PANEL" Product for Heavy Metals comply with Singapore Green Labelling Scheme (SGLS), Category 41: Panel Board

Sample Information	
Description	MICALITE DECORATIVE LAMINATE PANEL

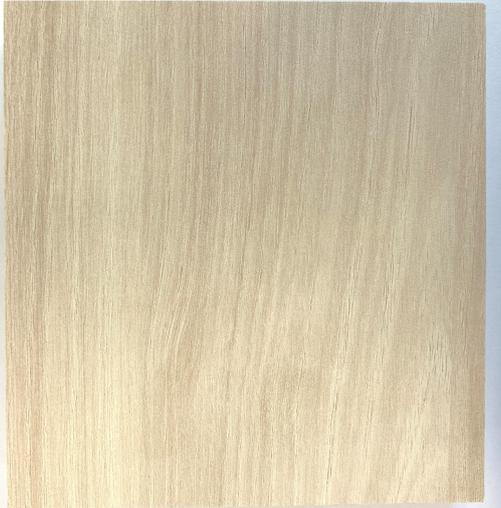
Sample	Sample Photo
MICALITE DECORATIVE LAMINATE PANEL (top view)
